SHAKTOOLIK COMMUNITY HEALTH CLINIC

2003 CODE AND CONDITION SURVEY

March 1, 2004

**Norton Sound
Health
Corporation**
*PO Box 966
Nome, AK
(907) 443-3311*

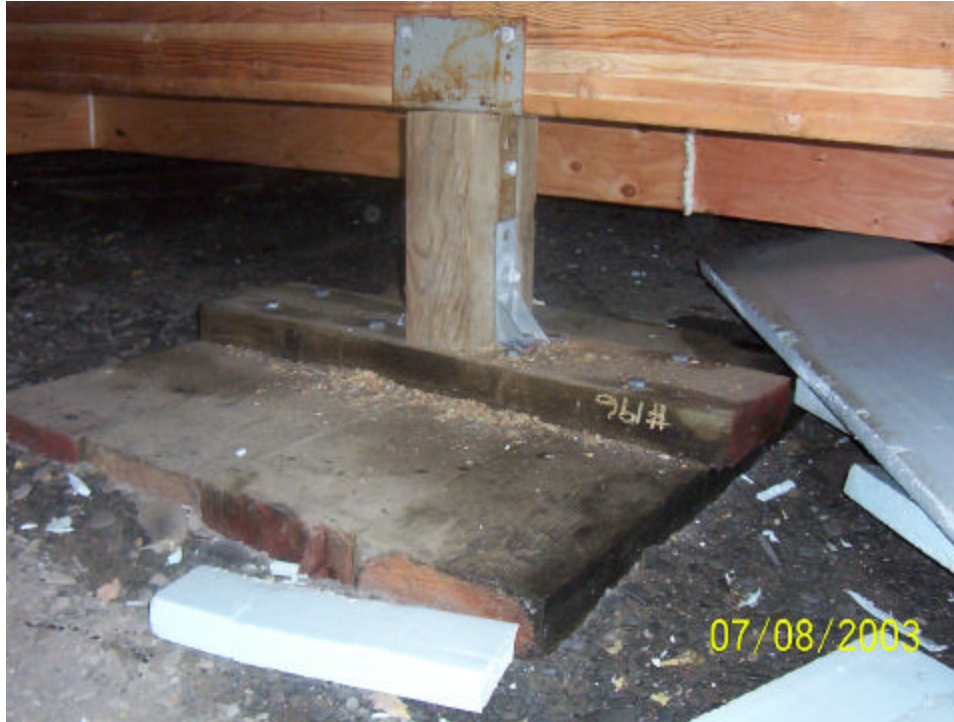
Reference
Number: **A01**

Description: **Building requires leveling**

Although leveled last year the bathroom door frame is still out of square. Building levels out in the summer months. In winter the frost causes movement.

As an interim measure, remove all the skirting, provide additional leveling to square up all corners of the building. Level building in the summer. Provide new glazing for existing windows and have the glass installed by a glazier. As a long term solution, have a Triodetic foundation engineered, remove existing insulated skirting, jack up the building, improve the bearing points by installing high density foam under the bearing blocks, installing the Triodetic system and reconnecting utilities. Size Triodetic system for future clinic expansion. Secure studs to floor and to rafters. Add rigid insulation w/plywood finish to underside of building. Refer to A05 for interior finishing. Note: This estimate item A01 considers only the cost of installing a new Triodetic foundation system.

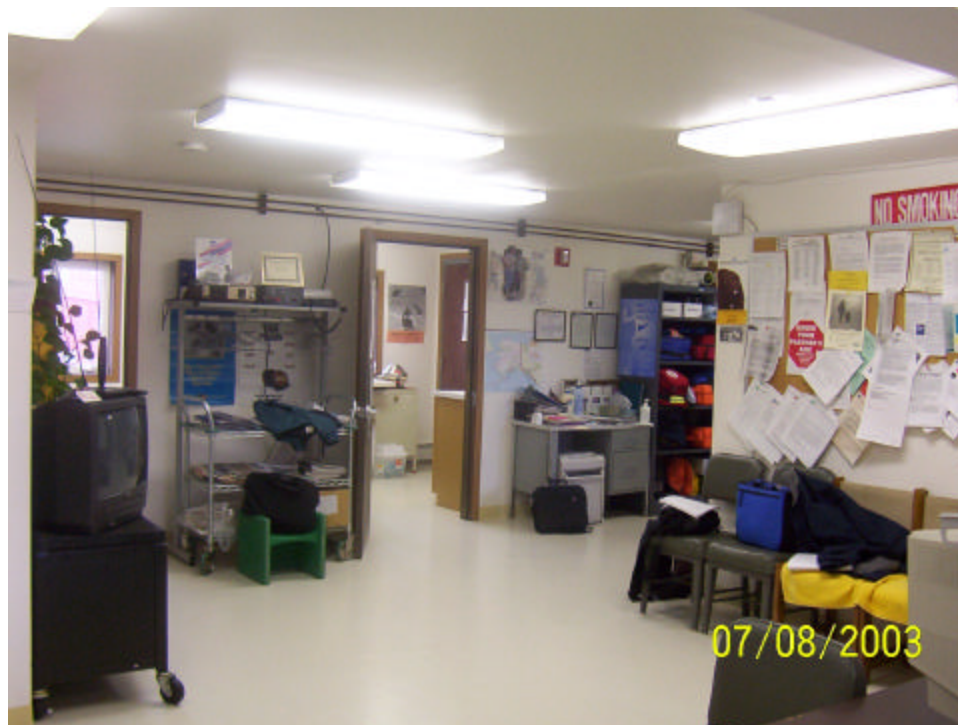
Reference Number: **A02**

Description: **Poor Space Utilization.**

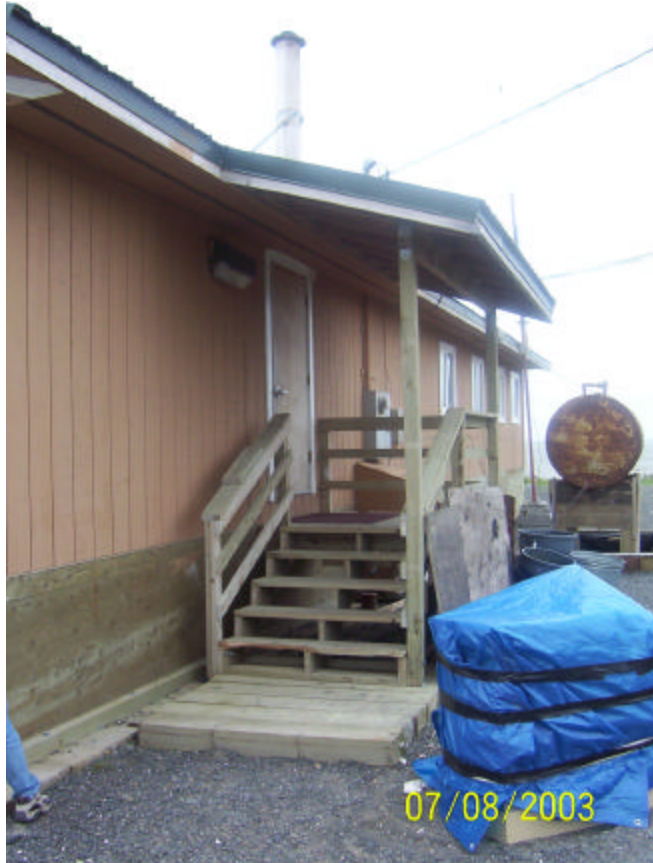
Reference
Number: **A03**

Description: **Trauma Room Size and Access**

Replace exterior door at back entry with a 42" exterior door. Replace interior door to trauma room with a 42" door. Increase landing and construct ramp from back landing to grade. This will require building the landing at grade with the building and reconstructing the roof overhang to accommodate the increased headroom requirements. Create consolidated area for emergency equipment. Change front doors to 42" wide with welded steel frame. Repair broken step at exterior back entry.

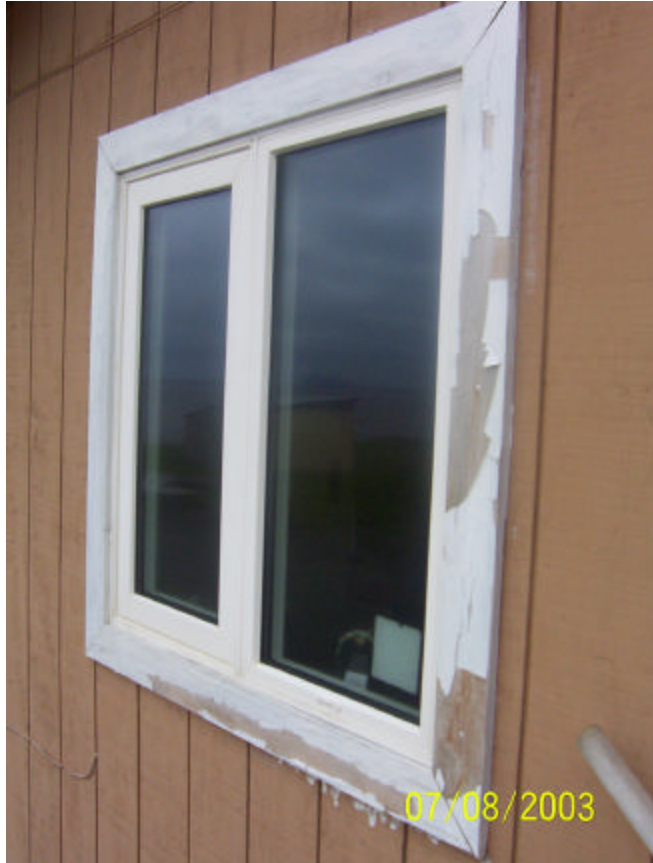
Reference Number:	A04
-------------------	------------

Description: **Exterior Finishing Required**

Exterior finishing not complete. Door and window frames need paint. Soffits, beams, columns need paint/stain finishing. Base skirting is not completely painted and trim is not painted.

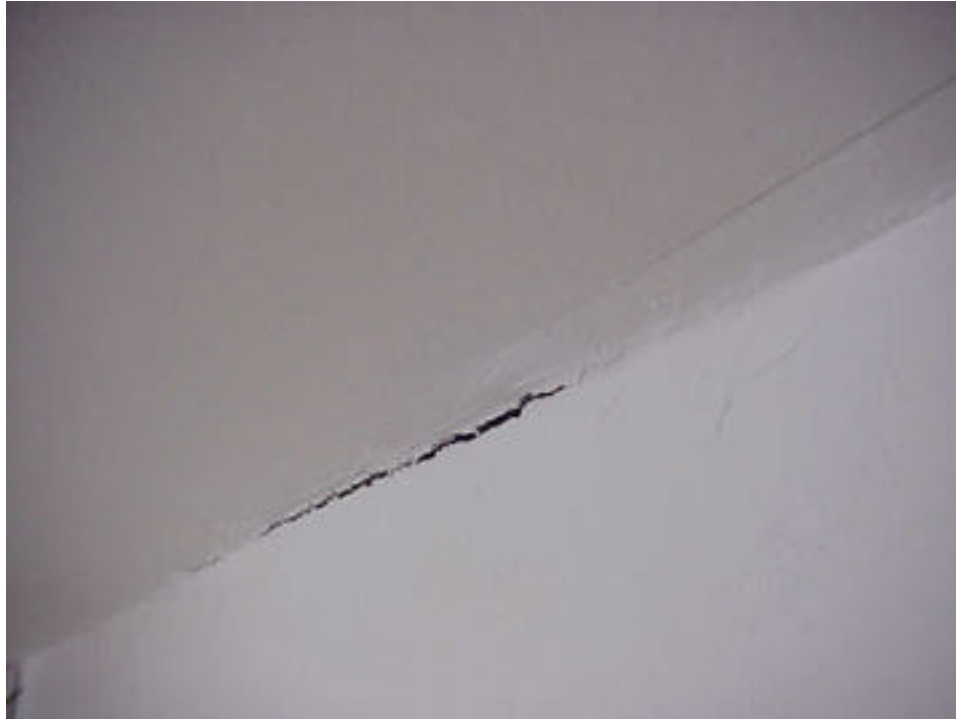
Reference
Number: **A05**

Foundation movement is evidenced in this clinic with separation occurring at the tops of walls and out of plumb door frames. In 2000, the clinic was still very new and this kind of movement in the first year was disturbing to the owner/tenants and to the review team. Over the last two years, the tenants have observed that the movement increases during the winter and is less prominent in the warmer months. It is important that this movement be monitored and procedures set up to level the building in response to ground movements to prevent structural damage.

Description: **Interior damage from settlement.**

Interior gypsum, doors/frames, baseboard, casework, etc. has been damaged by frost heave which occurs during the winter. Doors and frames have been reset, but cause of movement is still not fixed.

Need to stabilize foundation to preserve the building. Replace existing foundation with a Triodetic system. Replace stairs at front and back. Replace ramp at front. Fix doors and frames. Patch gypboard..

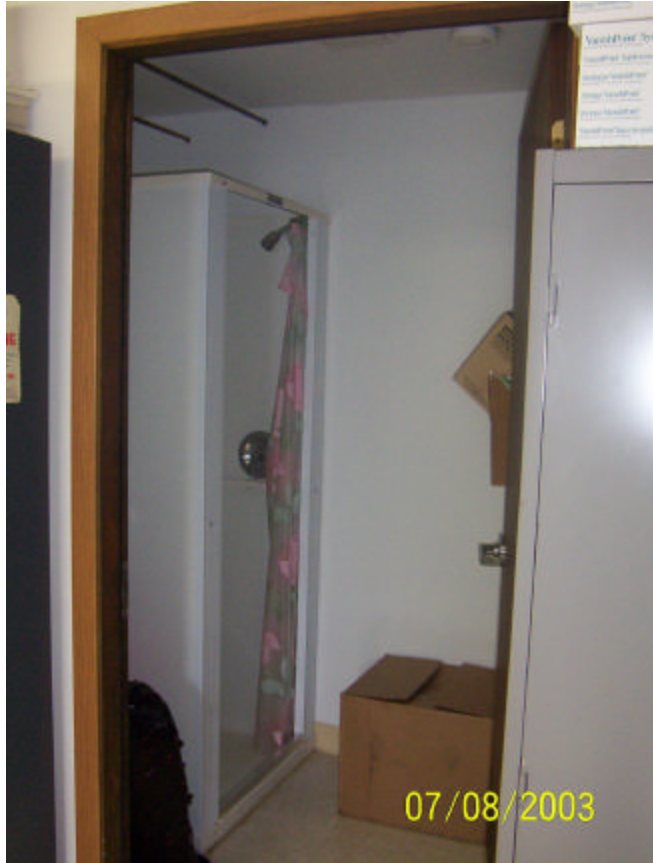
Reference Number:	A06
-------------------	------------

Description: **Accessibility Issues**

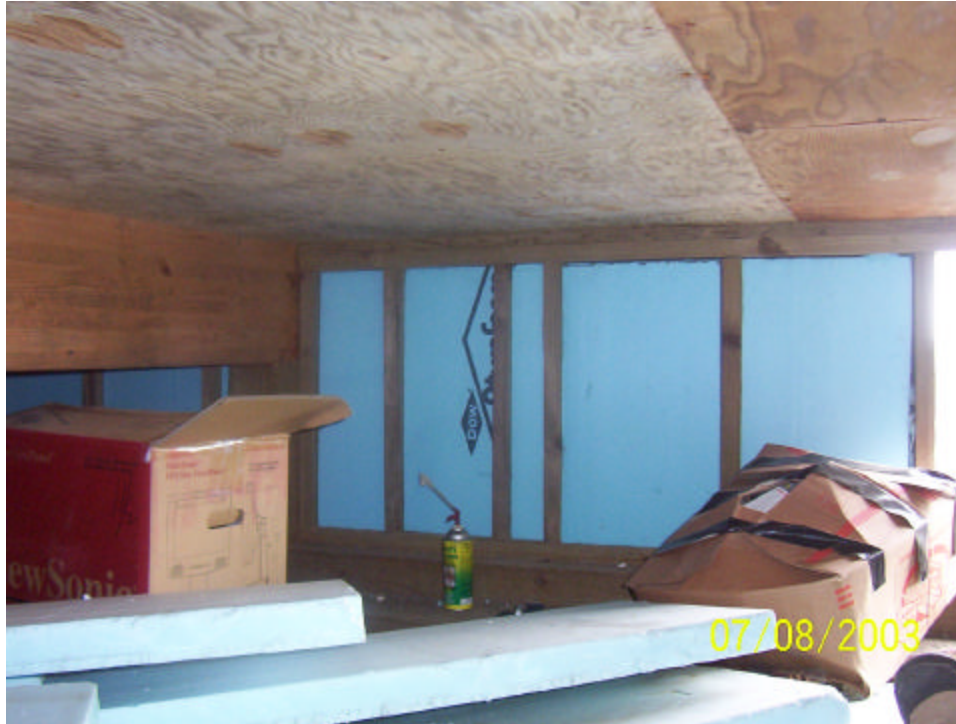
Reference
Number: **A07**

Description: **Junk in Crawlspace**

Miscellaneous construction debris is in crawlspace making access unsafe.

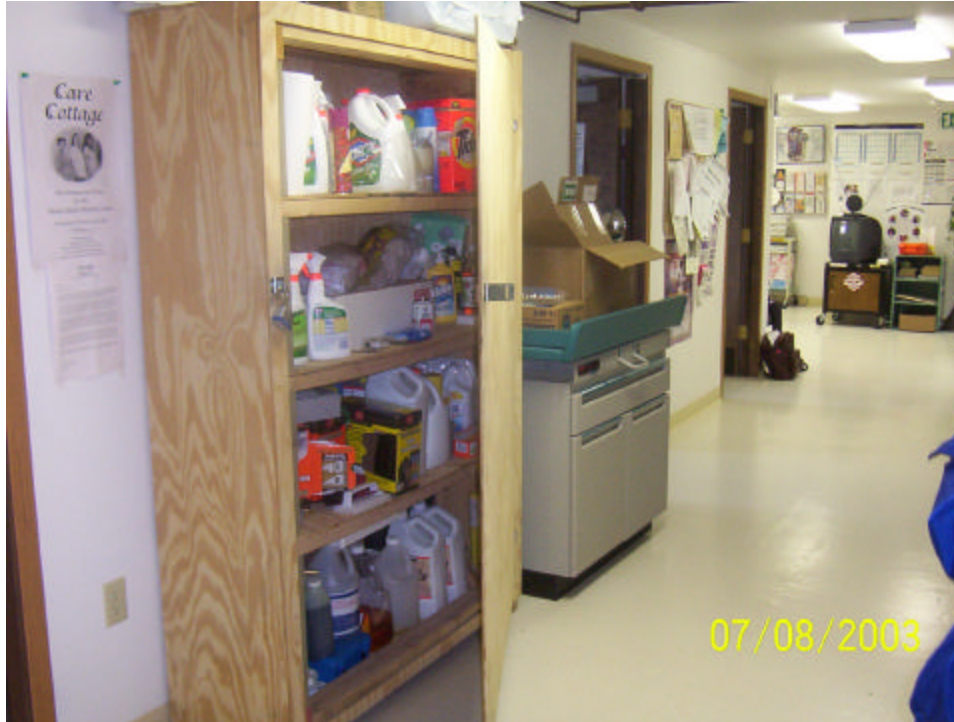
Reference
Number: **A08**

Description: **Inadequate space for specialty clinics.**

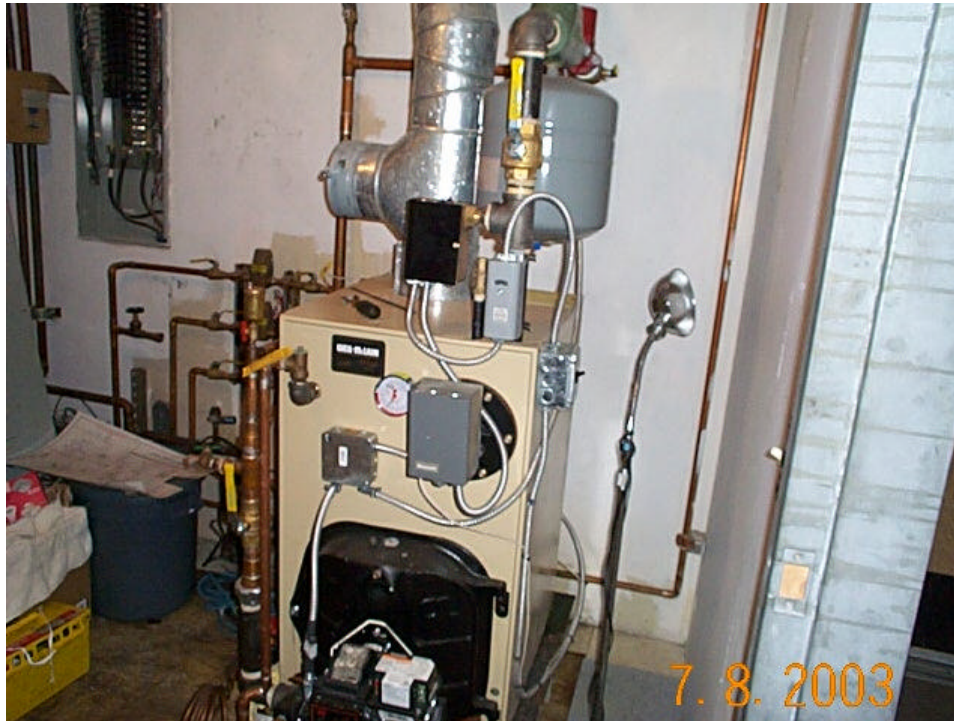
Reference
Number: **M01**

Description: **Provide Combustion Air for Boiler**

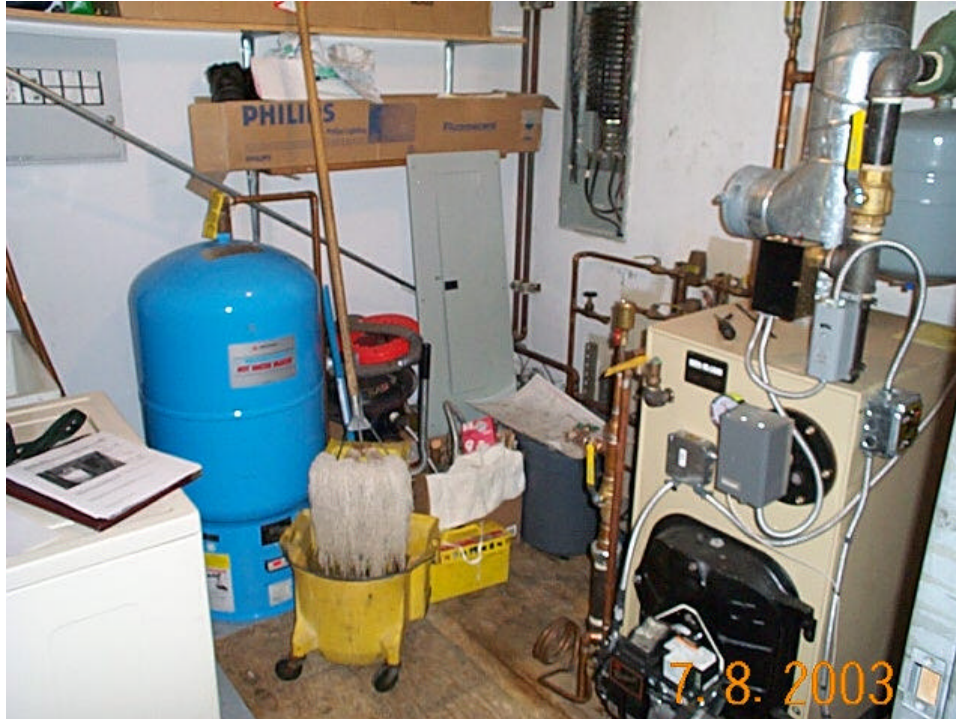
Reference Number: **M02**

Description: **Boiler Room Storage**

A large number of boxes, parts, equipment, etc. are stored in the boiler room making access for inspections, maintenance, and repair difficult (UMC section 307.1)

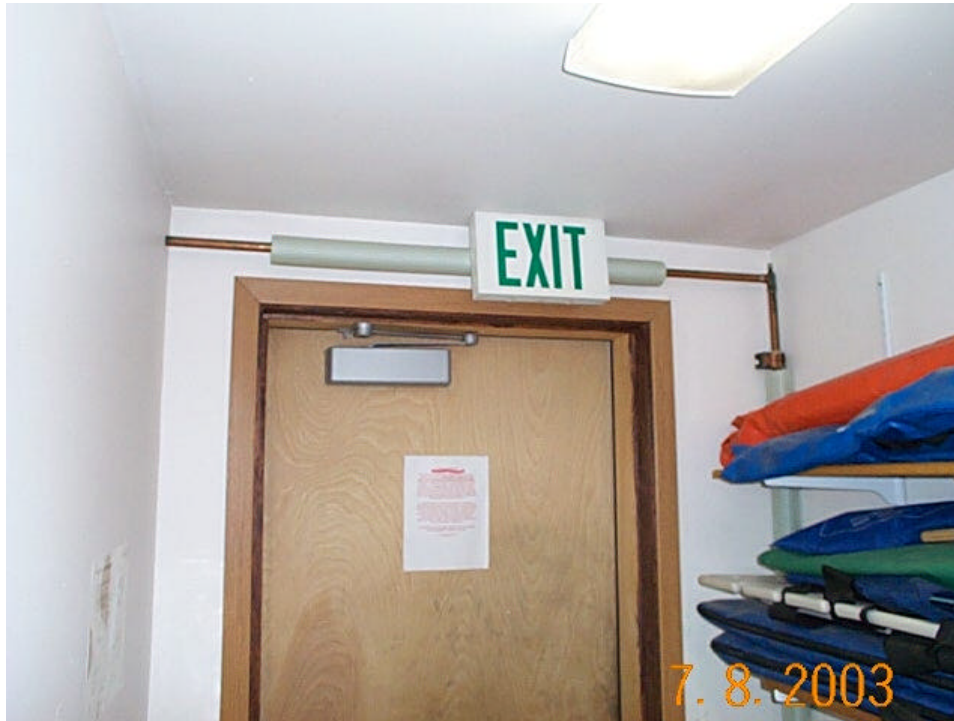
Reference Number: **M03**

The heating piping has been routed in the clinic to avoid freezing. Pipe insulation has been added which does not meet flame spread and smoke-developed ratings. The baseboard elements and enclosures are installed in all perimeter rooms and are fair condition.

Description: **Exposed Flammable Pipe Insulation**

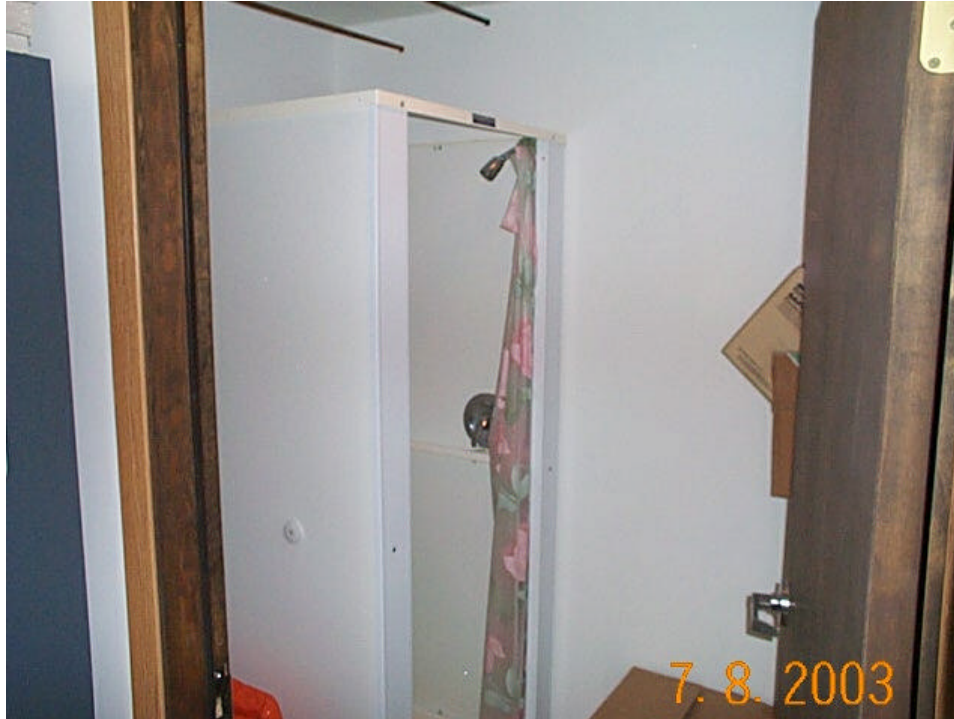
Reference
Number: **M04**

Description: **Non ADA Plumbing Fixture used In Shower Room**

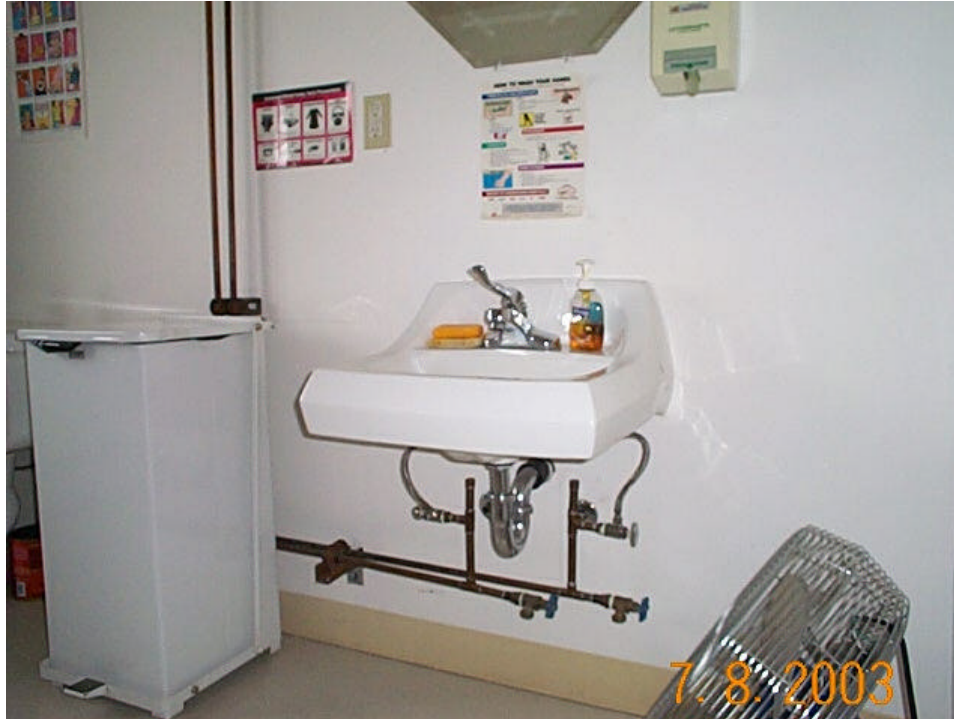
Reference
Number: **M05**

Description: **Non ADA Installation of Plumbing Fixture**

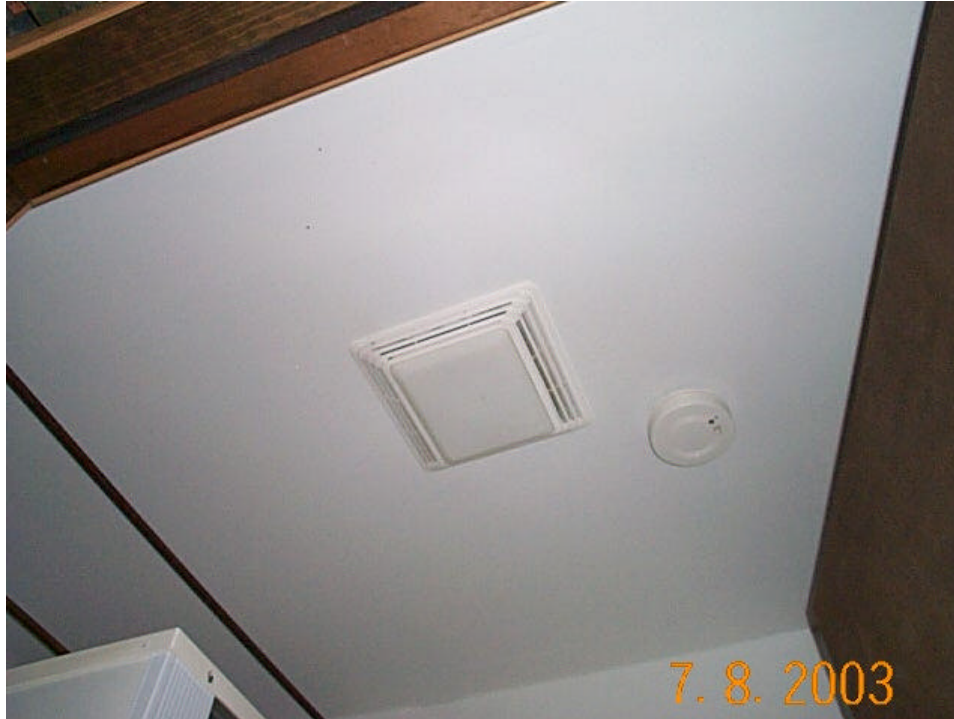
Reference
Number: **M06**

Description: **Ductwork for Exhaust Fans**

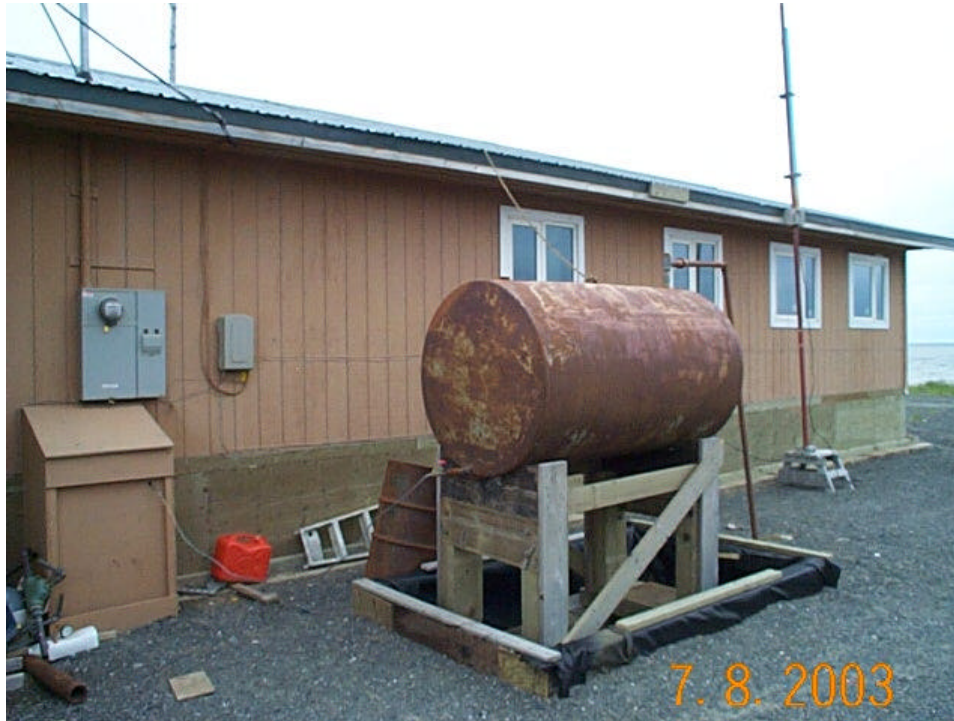
Reference
Number: **M07**

Description: **Fuel Oil Storage Tank and Piping**

The existing 360 gallon, rectangular, fuel oil storage tank has extensive rust and currently has an active leak. The tank does not meet UFC requirements for venting (UFC section 7902.1.11.4), piping (UFC section 7901.11.1.1) and valving (UFC section 7901.11.4).

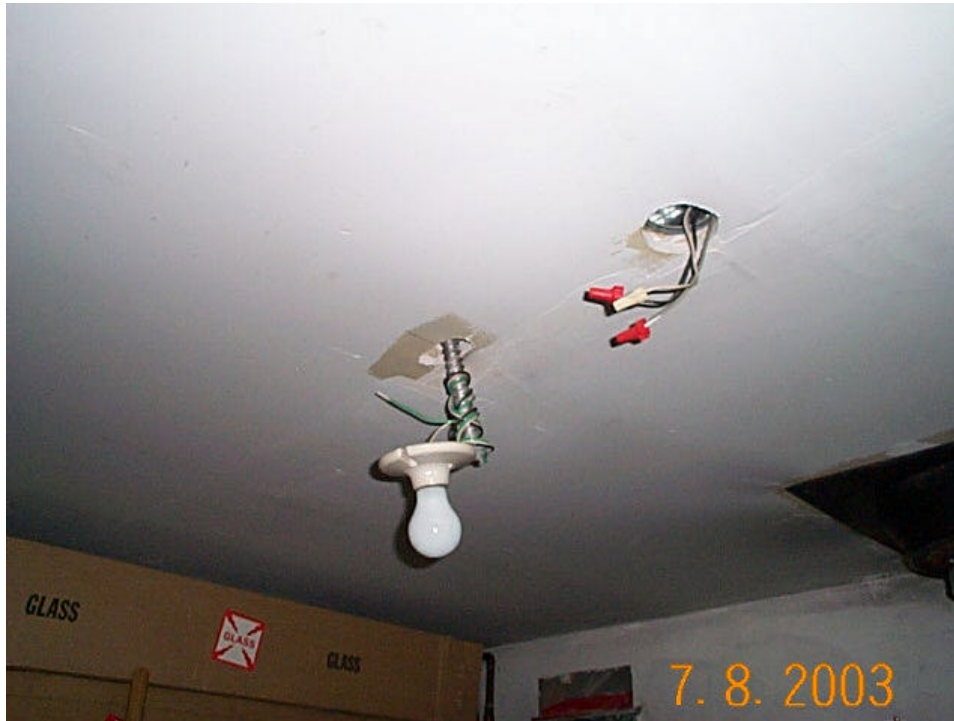
Reference
Number: **E01**

Description: **Exposed Wiring**

Exposed wiring was observed at the following locations
Connection to temporary lighting, connection to exterior lights, at a ceiling junction box, at one wall device box, and at numerous junction boxes located in the attic. (NEC 300-4)

Provide proper installation and termination of exposed wiring. Install concealed in walls or in flexible conduit. Provide junction box covers where missing.

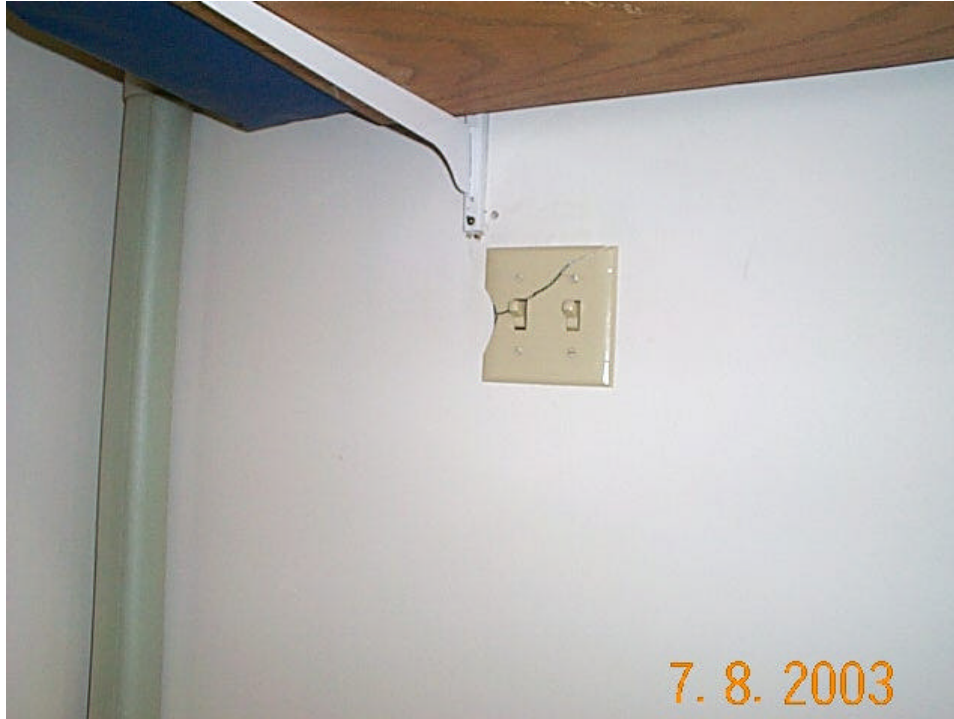
Reference
Number: **E02**

Description: **Damaged Cover Plates**

Device coverplates were observed to be damaged or missing at two wall light switches.
(NEC 300-4)

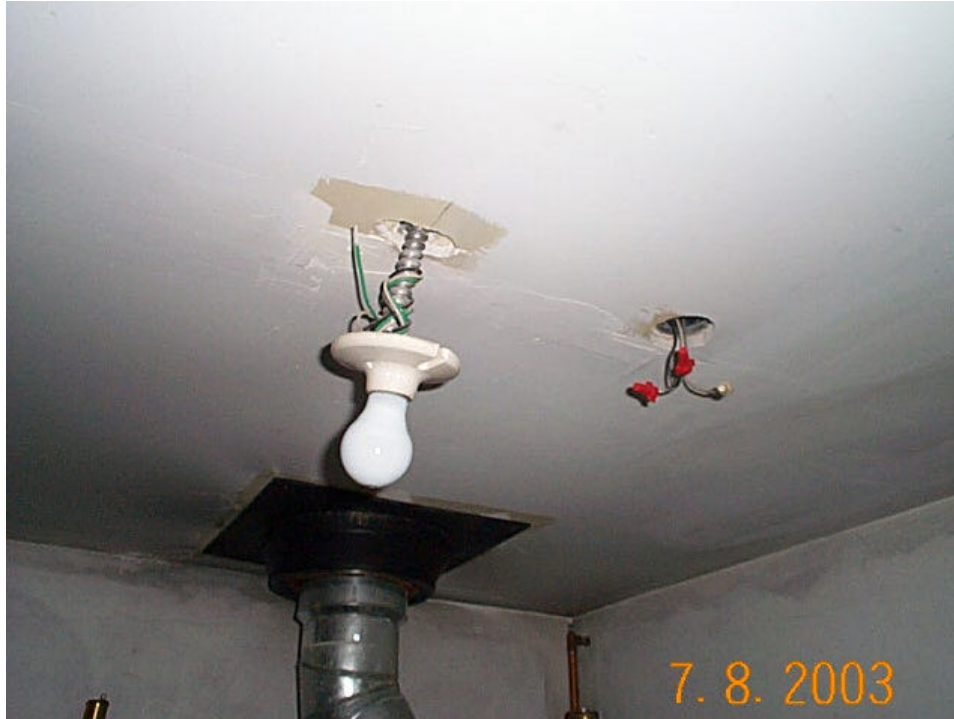
Reference
Number: **E03**

Description: **Damaged or Inappropriate Use of Lighting Fixtures**

Damage to or inappropriate use of lighting fixtures was noted as follows:
Temporary lighting fixture installed in one location.
(NEC 410-2 and NEC 410-5)

Replace with new fixture.

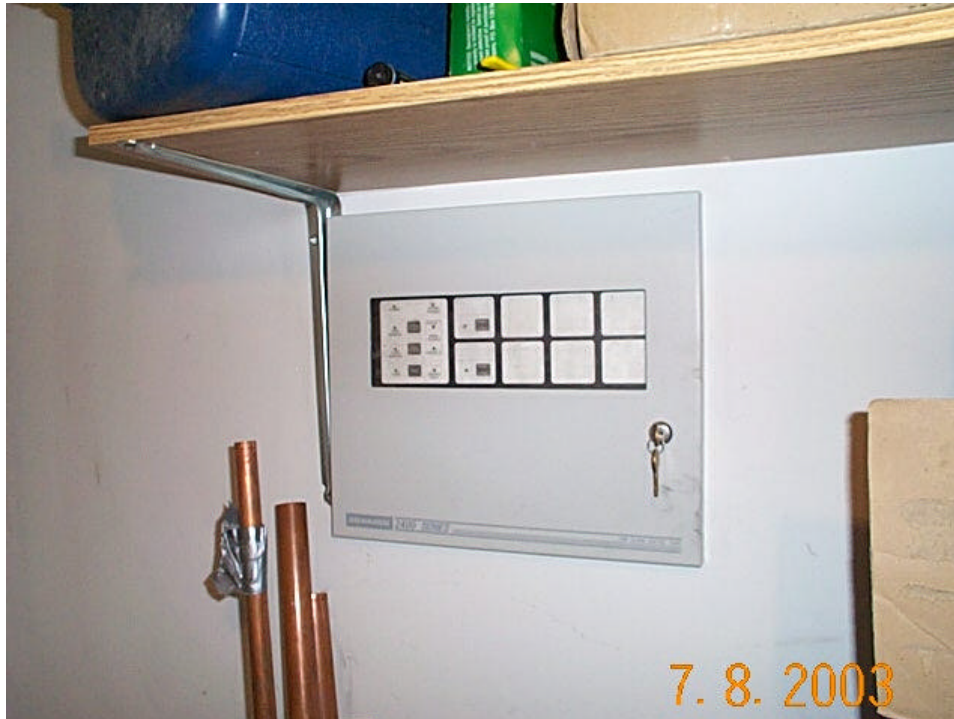
Reference
Number: **E04**

Description: **Fire Alarm Deficiencies**

The following deficiencies were observed in the automatic fire alarm system:

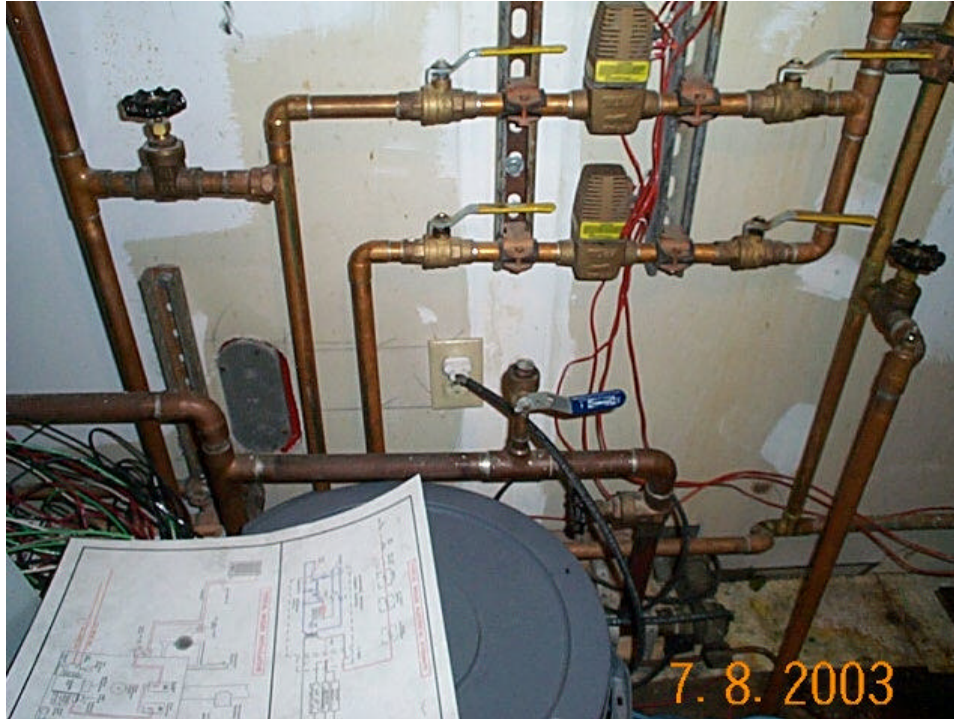
Reference Number: **E05**

Description: **Mechanical Room Heat Trace**

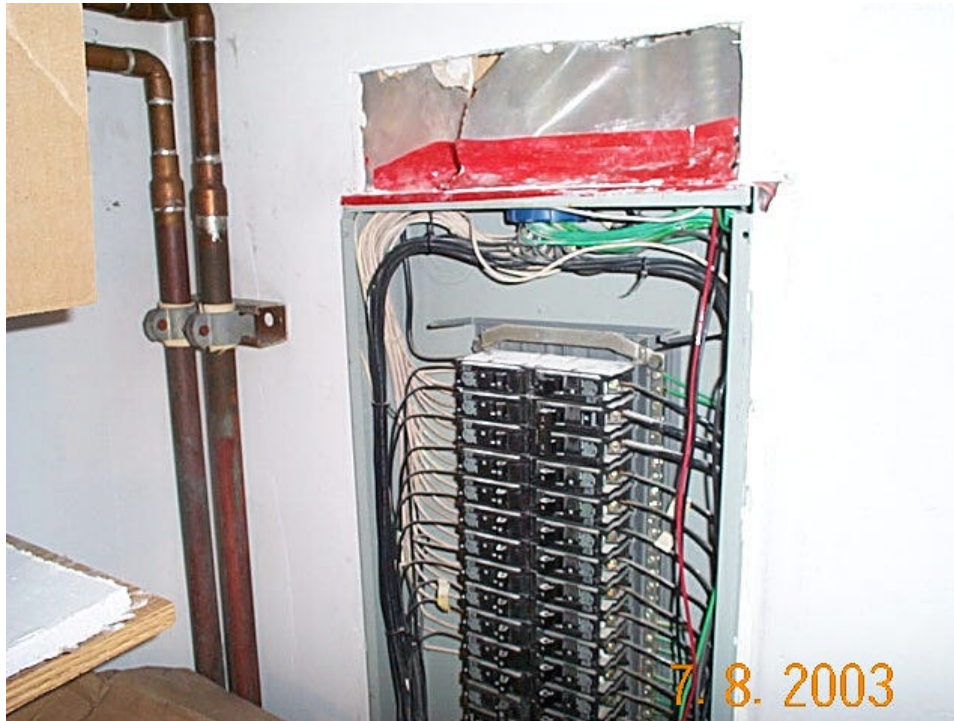
Reference
Number: **E06**

Description: **Panelboard Code Violations**

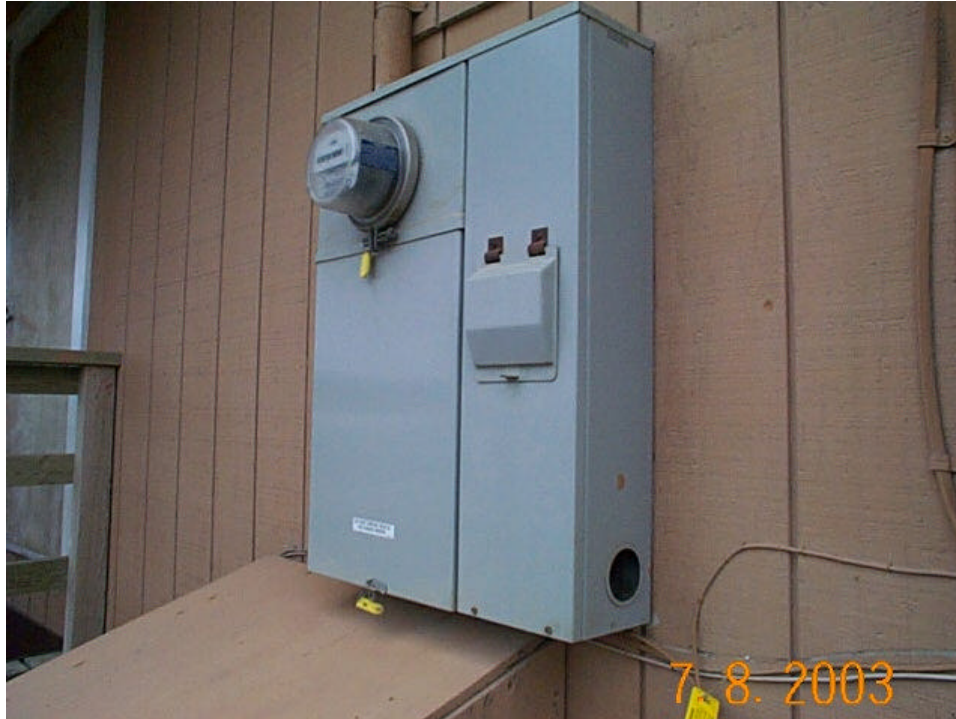
Reference
Number: **E07**

Description: **Meterbase Missing Knockout**
